# **INDOOR AIR QUALITY ASSESSMENT**

**Maria Hastings Elementary School  
2618 Massachusetts Avenue  
Lexington, MA 02421**

Prepared by:  
Massachusetts Department of Public Health  
Center for Environmental Health  
Emergency Response/Indoor Air Quality Program  
March 2007

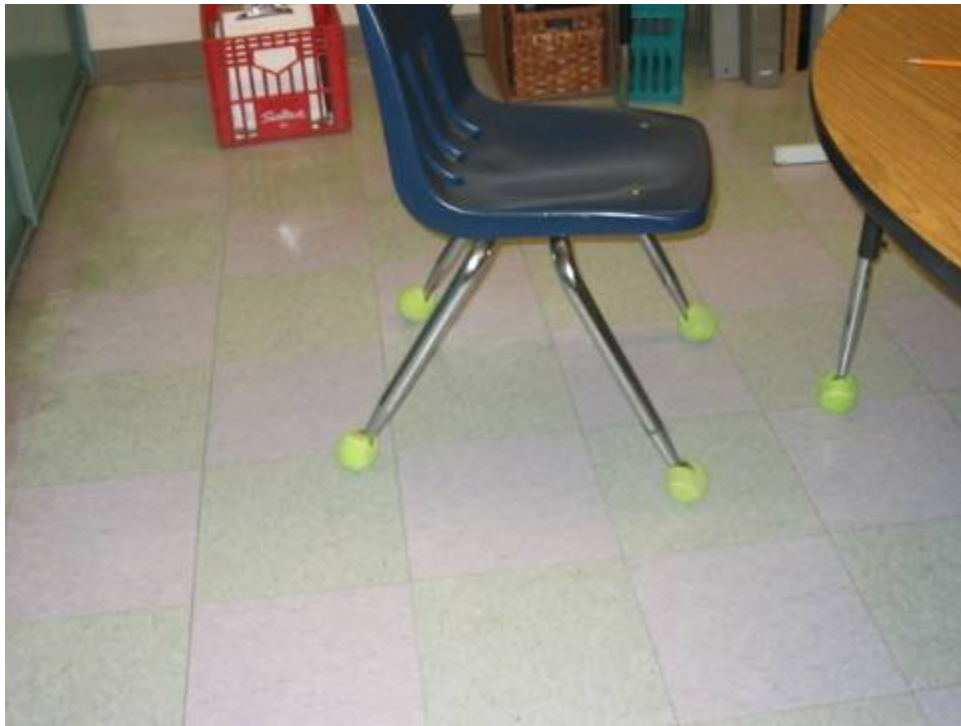
**Picture 31**

In an effort to reduce noise from sliding chairs, tennis balls had been sliced open and placed on chair legs in several classrooms (Picture 31). Tennis balls are made of a number of materials that are a source of respiratory irritants. Constant wearing of tennis balls can produce fibers and cause TVOCs to off-gas. Tennis balls are made with a natural rubber latex bladder, which becomes abraded when used as a chair leg pad. Use of tennis balls in this manner may introduce latex dust into the school environment. Some individuals are highly allergic to latex (e.g., spina bifida patients) (SBAA, 2001). It is recommended that the use of materials containing latex be limited in buildings to reduce the likelihood of symptoms in sensitive individuals (NIOSH, 1997). A question and answer sheet concerning latex allergy is attached as [Appendix B](#) (NIOSH, 1998).

**Tennis balls on chair legs**

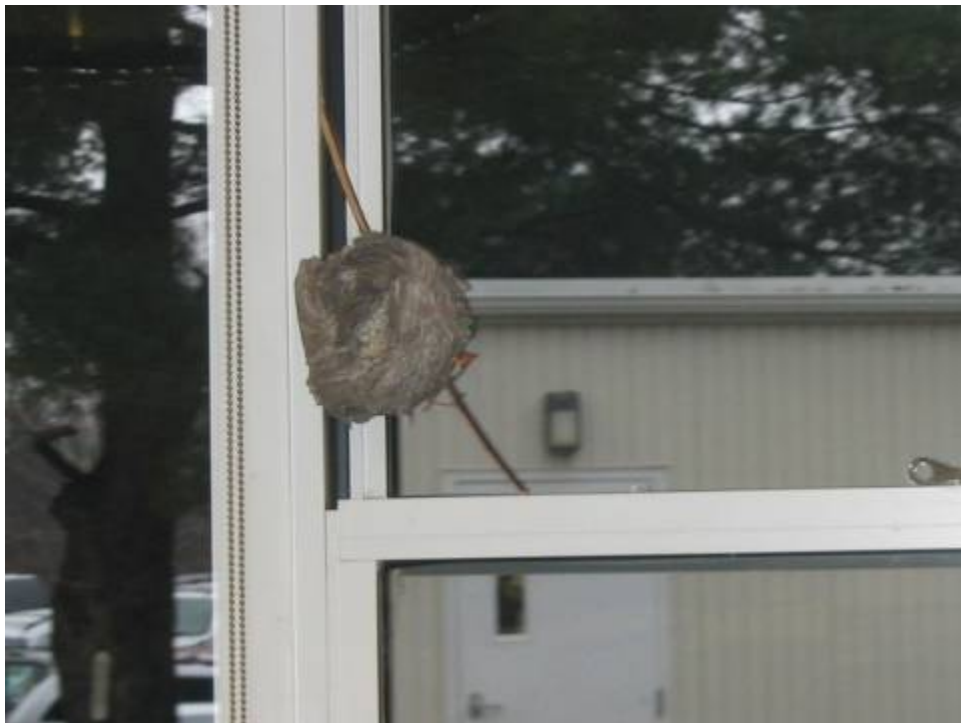
**Picture 32**

Lastly, inactive insect nests were observed in classrooms (Picture 32). Nests can contain bacteria and may also be a source of allergenic material. Nests should be placed in resealable bags to prevent aerosolization of allergenic material. These items should also be located away from univents fresh air diffusers.

**Insect nest in classroom**
